N-1744

January 1986

By M C Hironaka
and T J Holland

Blistering of Asphalt Pavement Overlay on Runway 14-32 at MCAS Beaufort, South Carolina

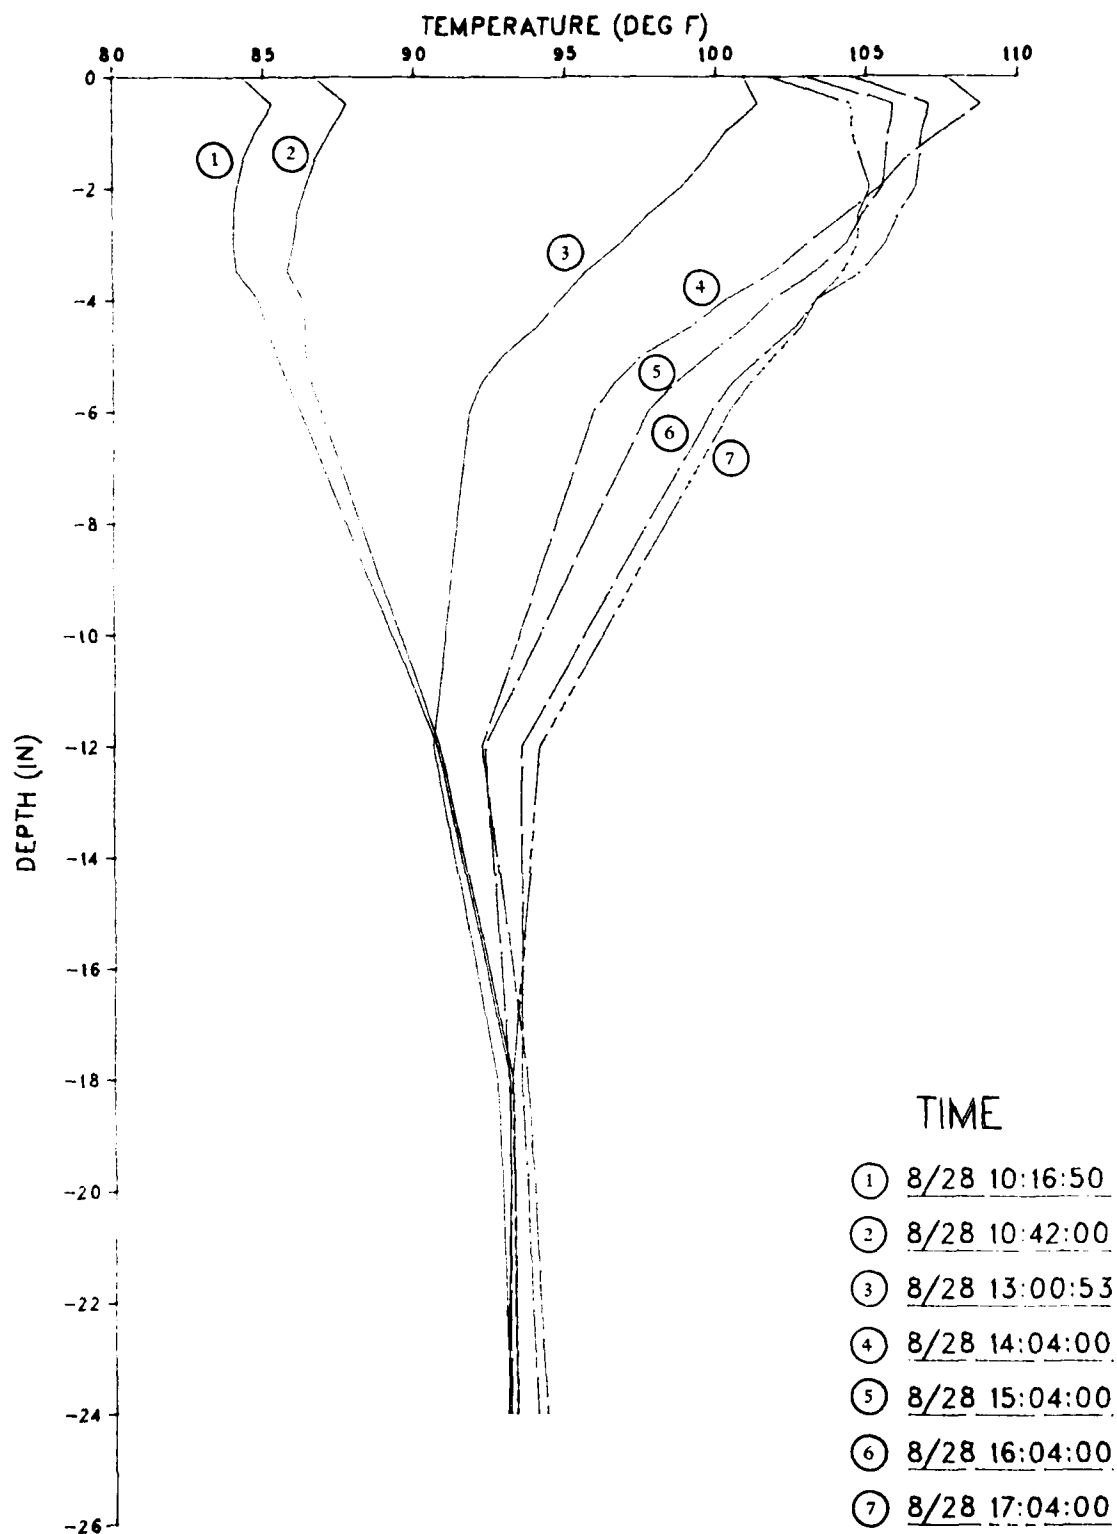
It is unlikely that gas pressures originating from ground water or moisture in the soil could be the cause of the diurnal blister behavior. As can be seen in the measured temperature profiles of Figures 13 and 14, the large diurnal pavement surface temperature variation dissipates into a steady state condition below about the 1-foot depth. Thus, since diurnal temperature effects are minimal beyond this depth, the blister behavior cannot be attributed to gas originating from deeper depths on a diurnal basis. Since the ground water table is located much deeper than 1 foot (10-foot deep inspection wells were dry), this eliminates gas originating on a diurnal basis from the groundwater as the cause of the blisters. Gas originating from moisture in the soil at shallower depths above the water table can also be eliminated as the cause of the blisters because of two reasons: (1) the soil, which is sandy, is much more permeable to gases than the dense asphalt pavement layers and thus any pressure buildup will dissipate through the soil and not through the pavement structure, and (2) gases present in the soil moisture, if they were to migrate into the blisters, would with time become depleted and blisters would cease to form. Since the blisters continue to form diurnally, blister formation cannot be attributed to gas pressure buildup in the soil layers beneath the pavement structure. An additional indication

Figure 13. Temperature profiles at Site 1 near blisters 1 and 2.

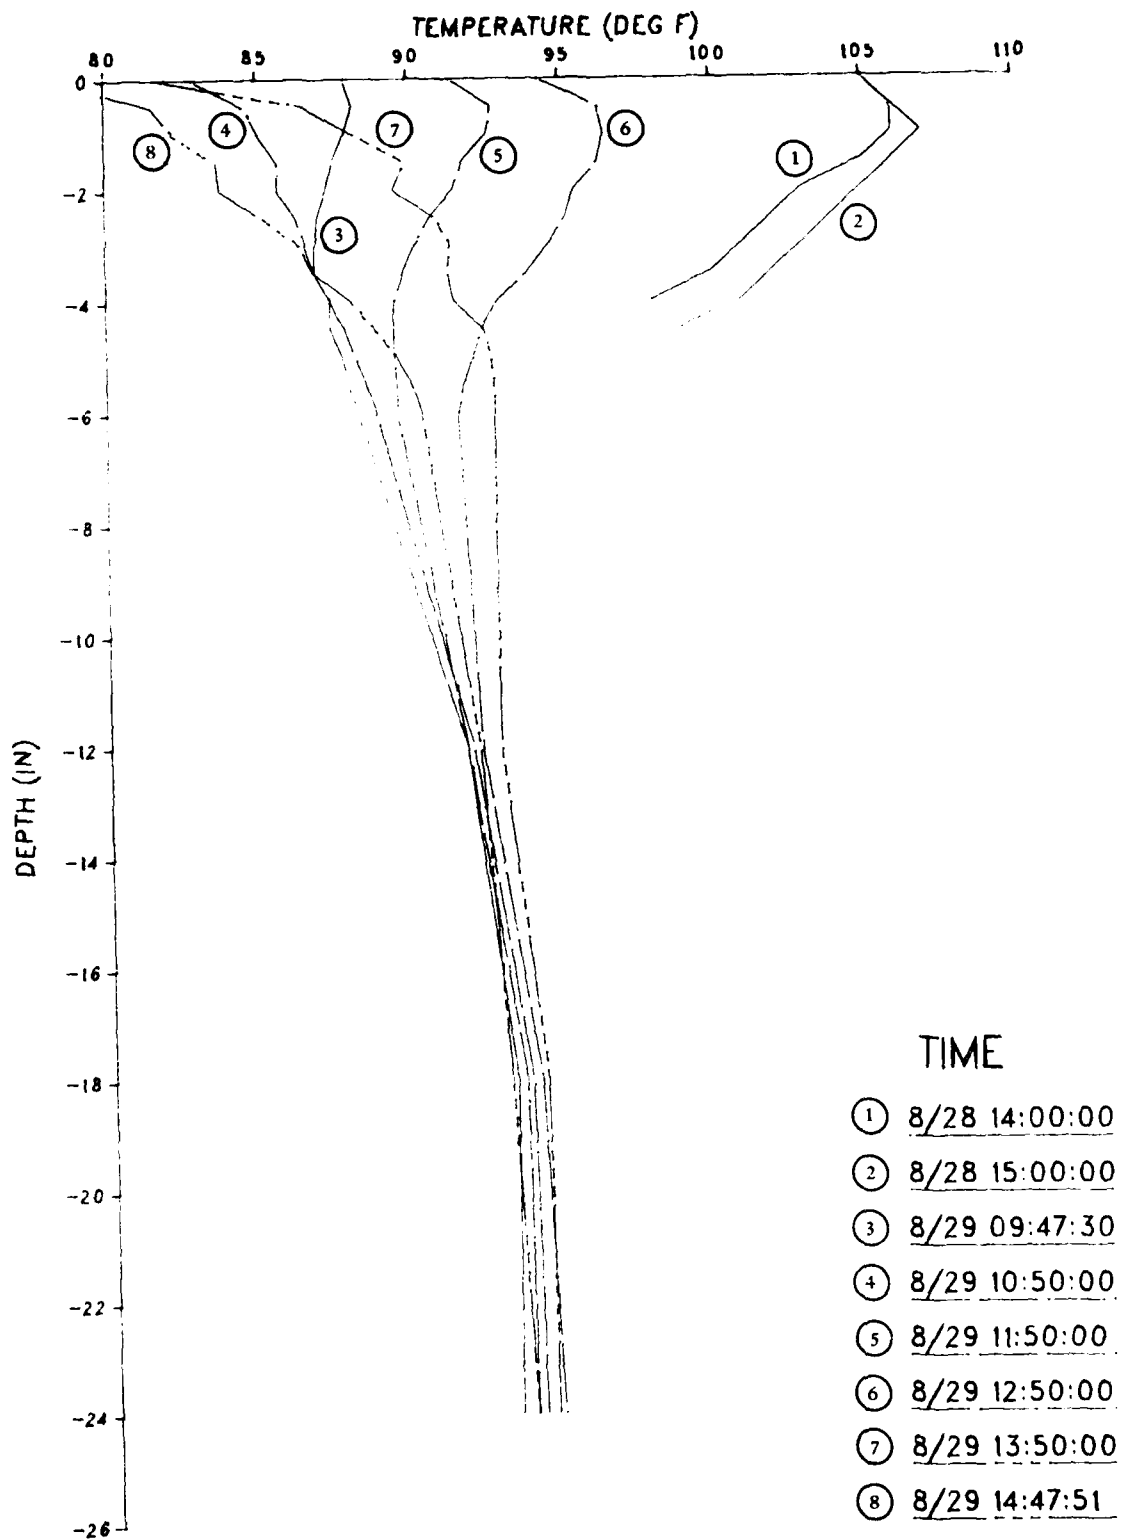
Figure 14. Temperature profiles at Site 2 near blisters 3 and 4.

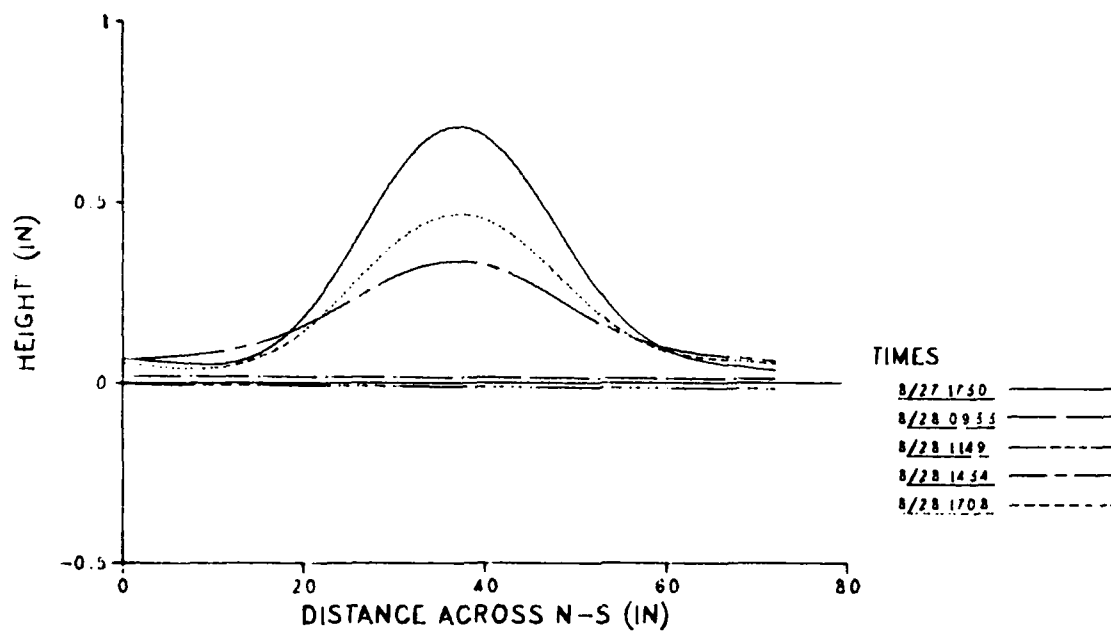
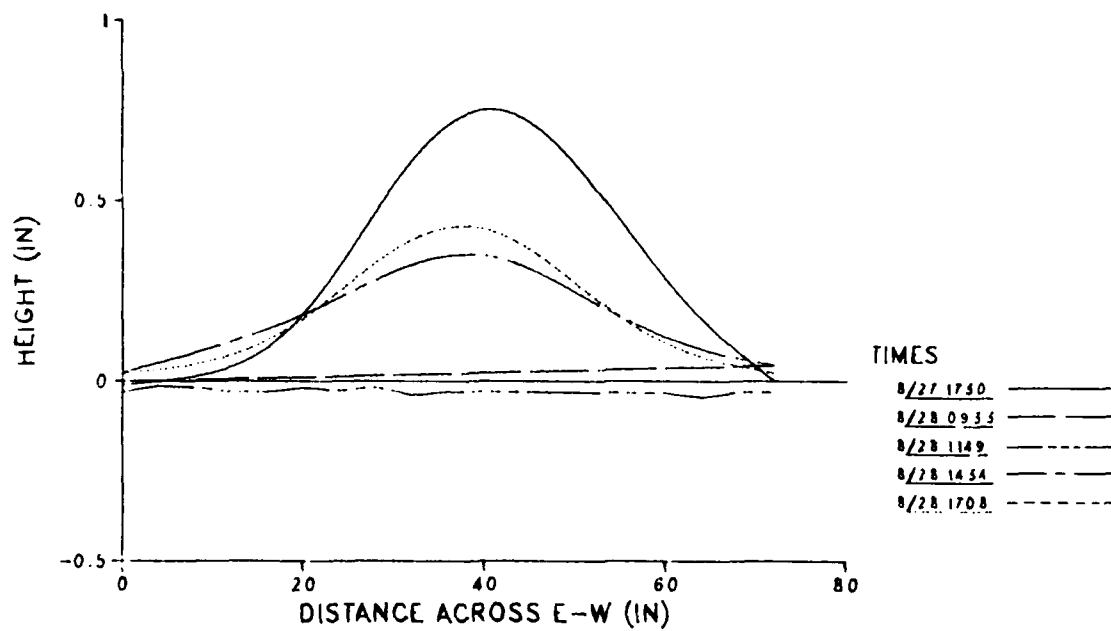
The blisters rise and fall throughout each day with changes in ambient pavement temperatures as shown in Figures 15 through 18. During the cool morning hours, the blisters are absent. As the pavement temperature increases, the blisters begin to rise. Subsequently, as the temperature decreases, the blisters recede. When they are punctured, the blisters deflate. This implies that they are caused by internal pressure buildup. The blister volume changes calculated with the blister surface elevation data are shown in Table 4.

Figure 15. Profile changes of blister 1.

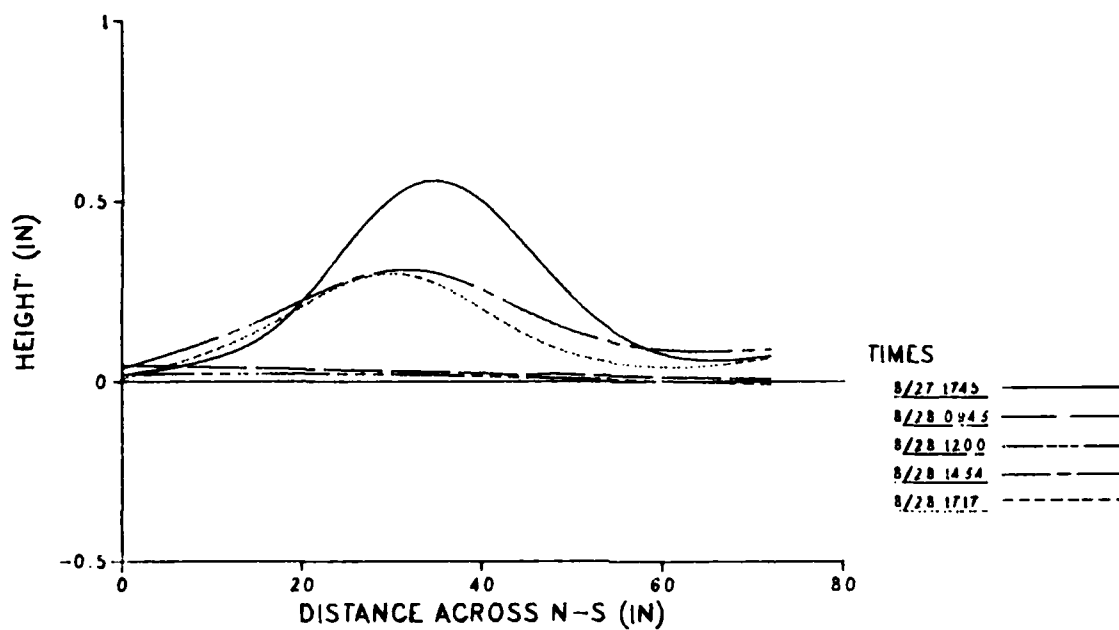
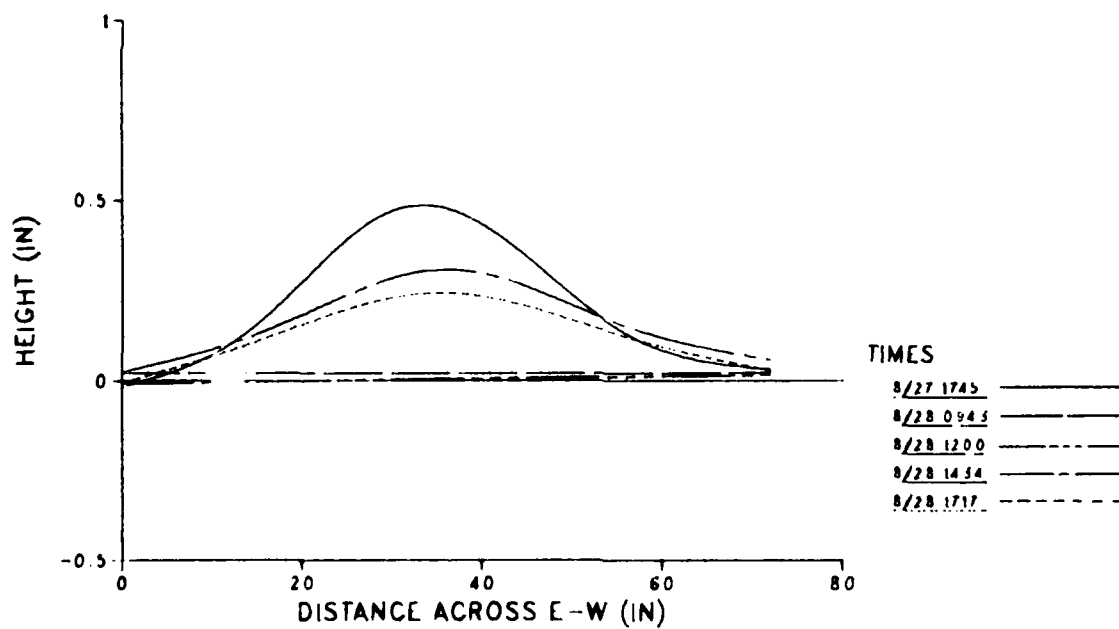
Figure 16. Profile changes of blister 2.

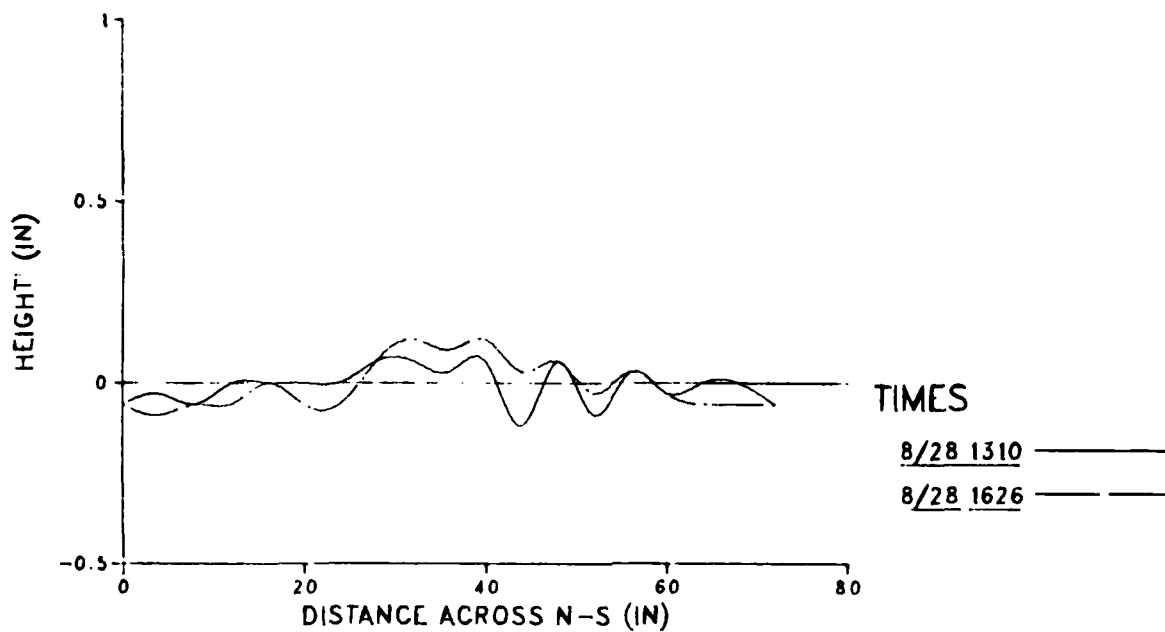
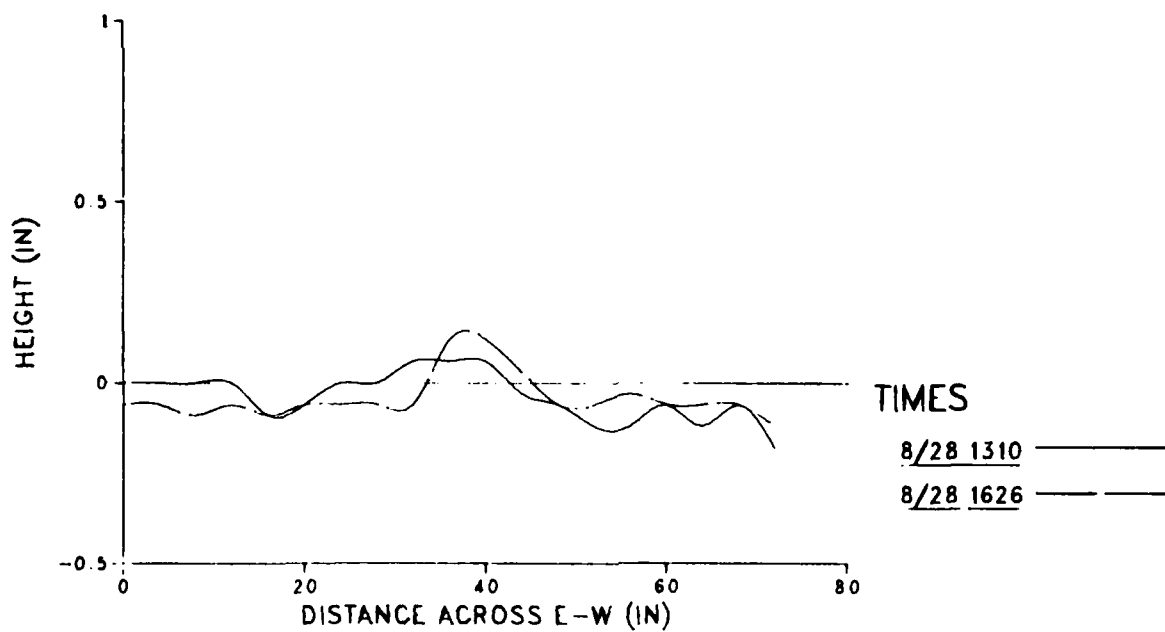
Figure 17. Profile changes of blister 3.

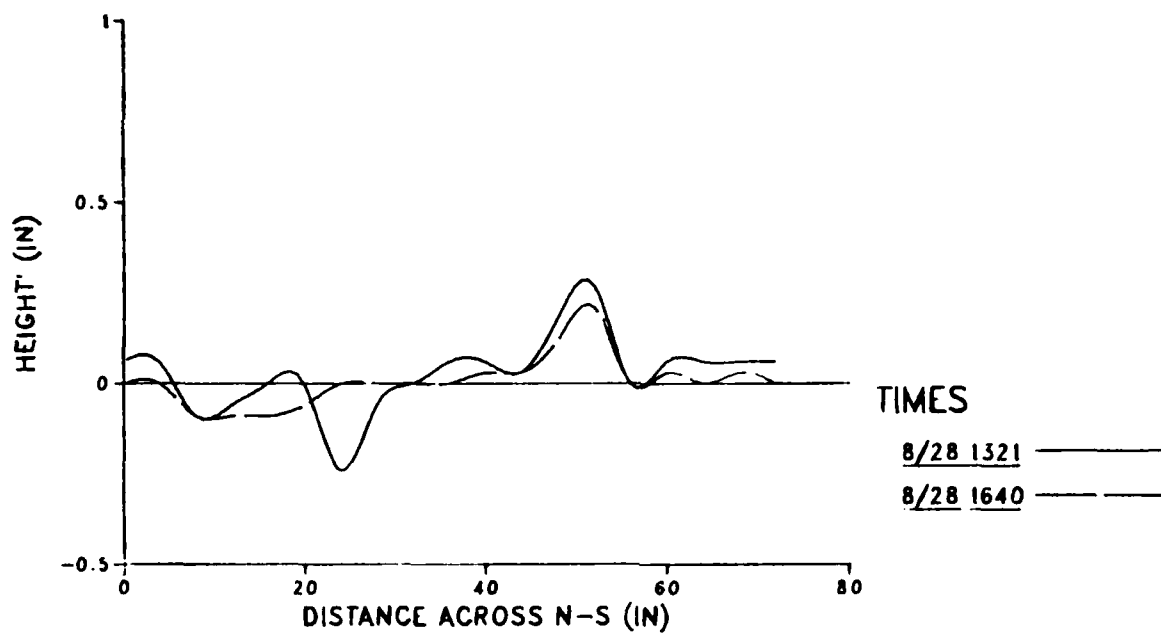
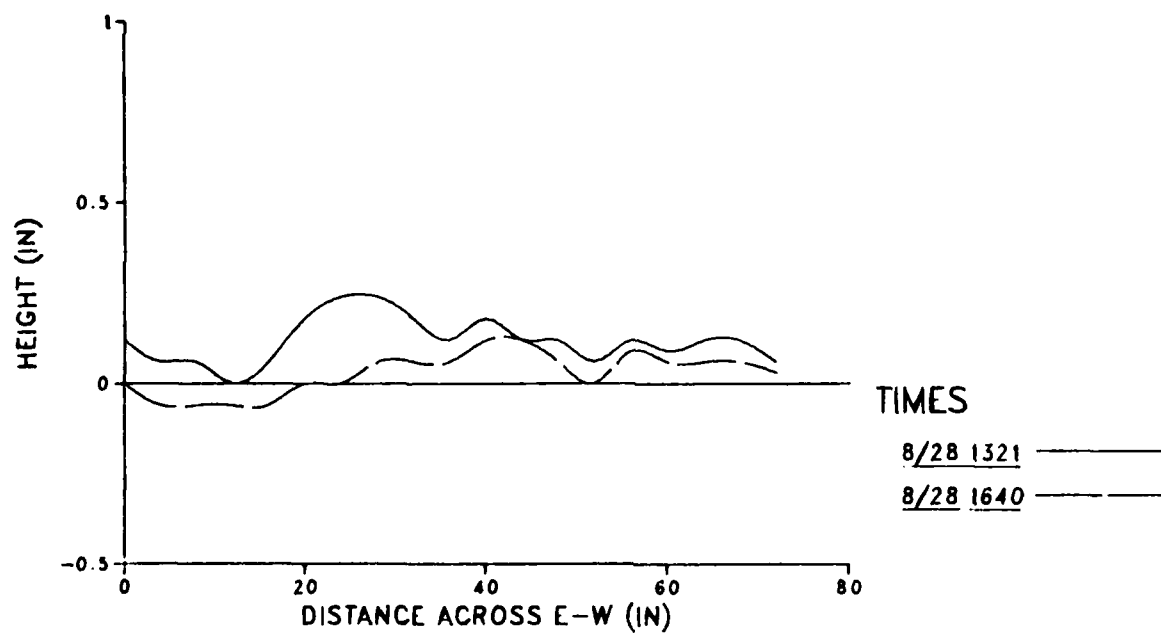
Figure 18. Profile changes of blister 4.

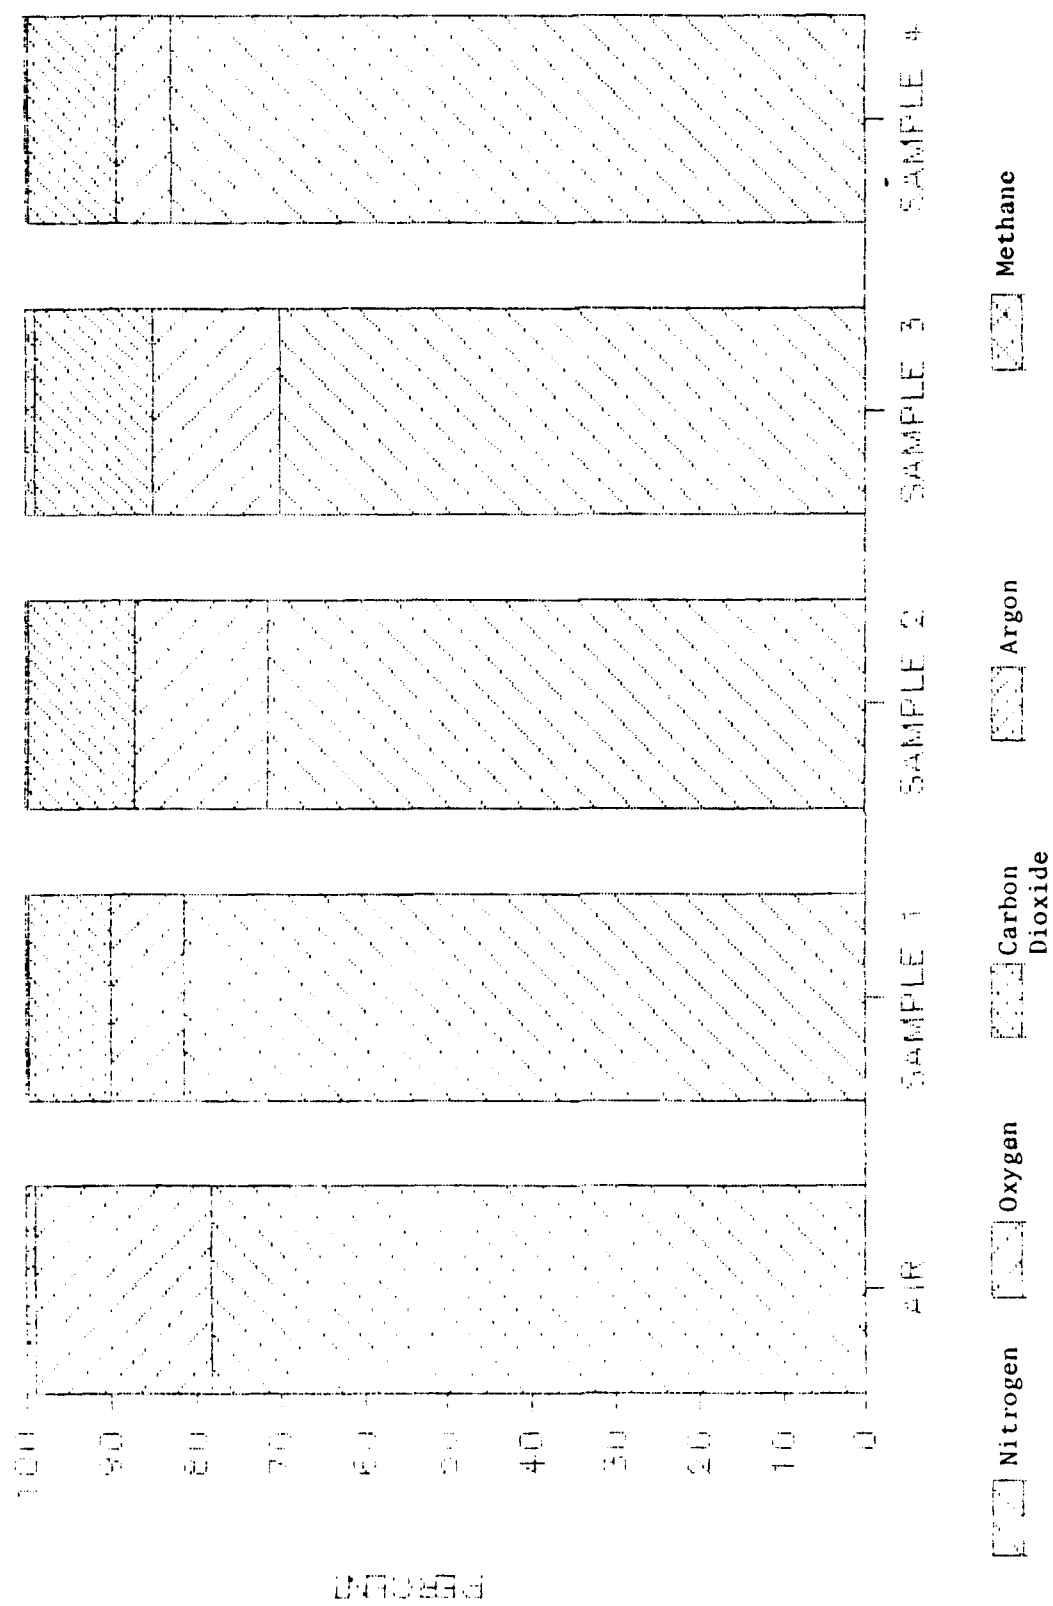
The gas samples from the four blisters were analyzed for saturates, unsaturates, and normal gases in a Hewlett-Packard Gas Chromatograph (Model 5880). The results of the analyses are shown in Appendix C. Figure 19 summarizes all of the detected constituents of the gas samples as compared to the constituents contained in air. The constituents of the blister gas are the same as those found in normal air. The deviation of the amounts of each constituent from the norm is explained later in this report.

Figure 19. Composition of air compared to measured values from gas samples.

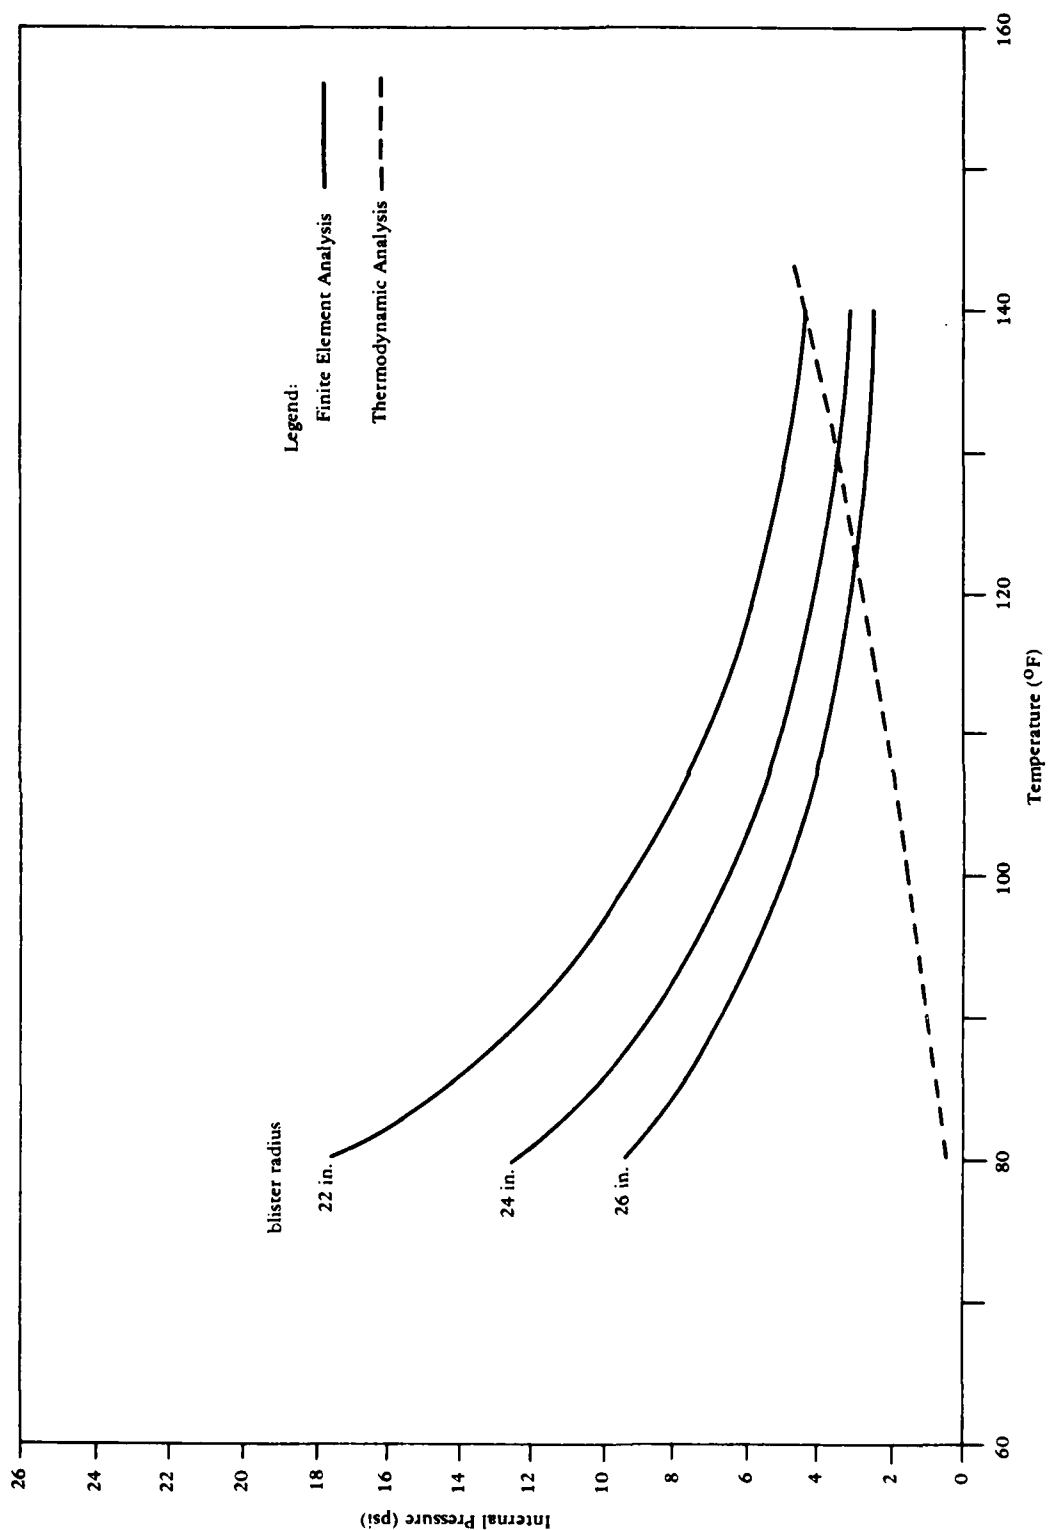
8. The finite element analysis simulating the behavior of blister 1 resulted in the calculation of pressures that were higher than those obtained in the thermodynamic analysis. The difference in the calculated pressures can be explained by the following reasons: (1) the finite element program treats the asphalt overlay as a homogeneous material (it is not), (2) cracks are present in the blistered overlay which reduces the bending stiffness, (3) the actual temperature could be several degrees higher than that measured because of the insulating effect of the trapped gases (i.e., the subsurface layers act as a heat sink), and (4) the initial starting point of 80°F used in the thermodynamic analysis may be higher than actual field conditions.

Figure 23. Internal pressures required for a crown deflection of 0.69 inch for various size blisters computed by the finite element method compared to pressures computed in the thermodynamic analysis of blister gases and water vapor.

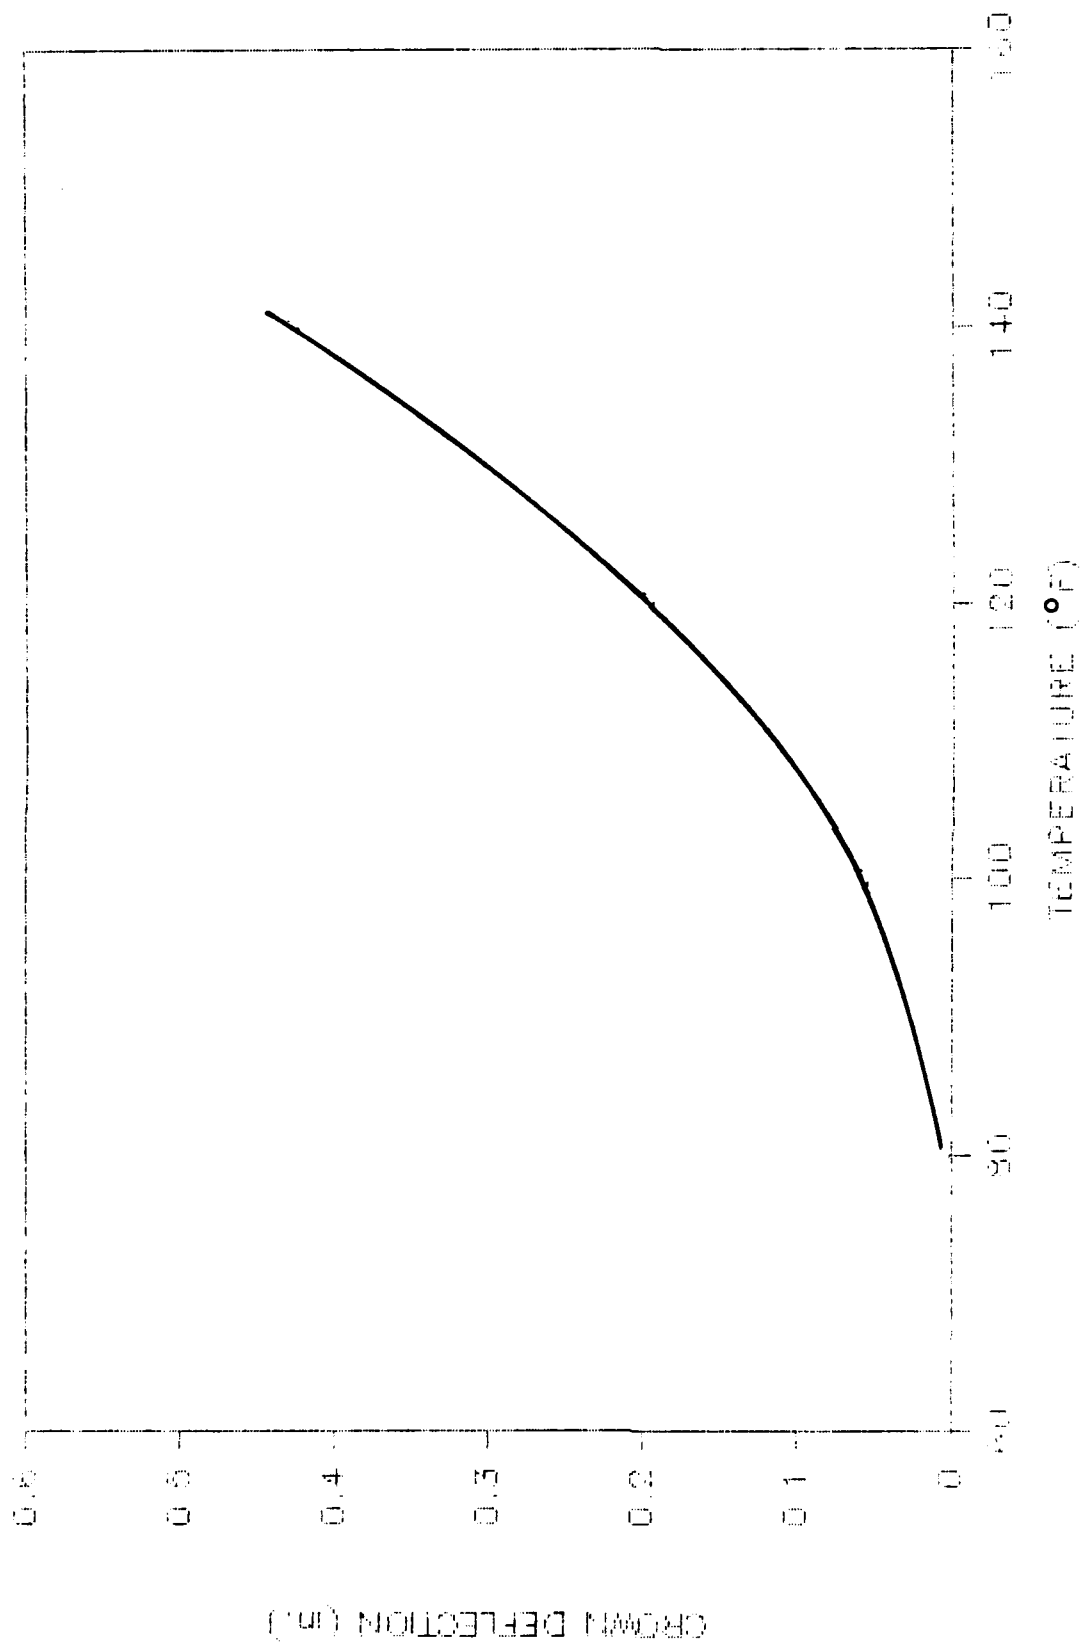
An analysis was made to determine the effect of a 2-inch overlay on the pavement in its present condition with the 1-1/2-inch overlay in place. The finite element model was modified to analyze a 2-inch overlay. Although not entirely correct, it was assumed that the new overlay provided resistance to all of the bending and membrane stresses and that the present overlay was cracked. The results of this analysis are summarized in Figure 24 where it can be seen that significant blister crown deflections were calculated. Thus, although not entirely conclusive with the above limited information, the possibilities are good that blistering will occur even with the added 2-inch overlay.

Figure 24. Crown deflections at various temperatures for a 24-inch radius blister in a new 2-inch thick overlay over the existing pavement.
